TECHNICAL BULLETIN

LT310-001

Discovery II Td5 Poor Starting/Noisy Fuel Pump

Discovery Series II (LT)

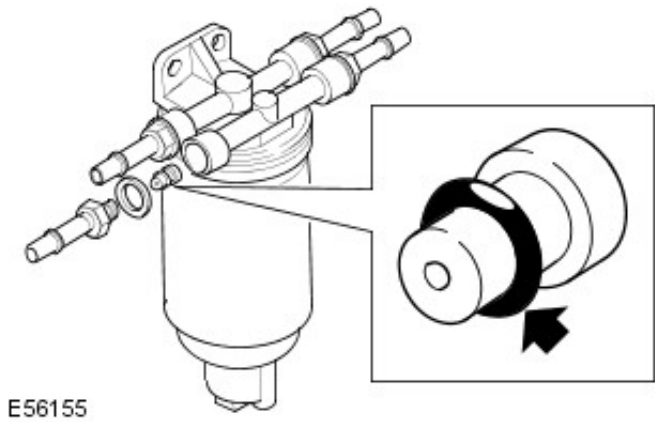
Cause: The O-ring seal on the fuel filter air bleed valve may be split, allowing air into the fuel system (If air is being introduced into the fuel system, it will make the primary fuel pump sound noisy).

5 Withdraw the air bleed valve from inside the brass fitting. Inspect the O-ring and plastic body for splits and damage.

6 If the O-ring is damaged, renew parts provided in the service repair kit.
